5. Body Sealing

Three Bond 4101 (004403063)

Body Sealing

BODY STRUCTURE

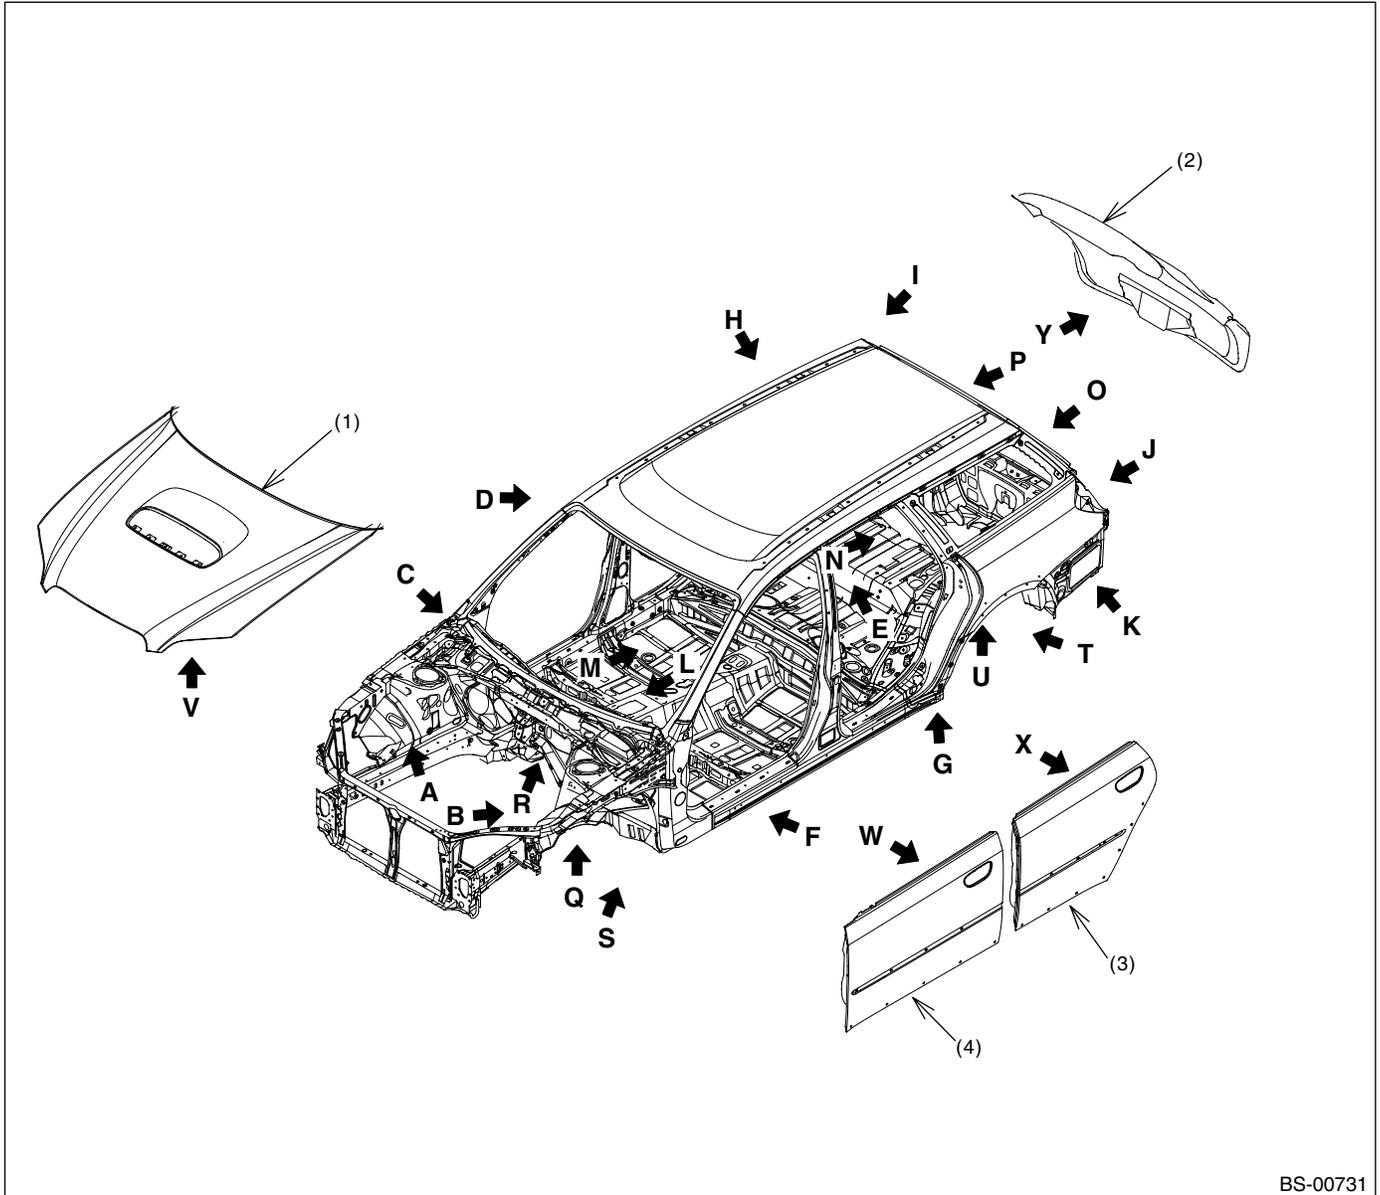
BS-00731

Used material:

- Common for wagon and sedan model

(1) Front hood

(3) Rear door

(4) Front door

(2) Rear gate

CAUTION:
Sealer already has been applied to hood, door, and rear gate in replacement condition.

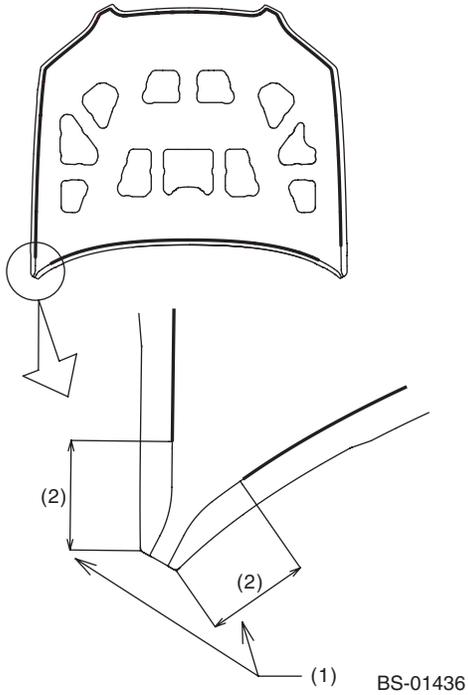
BS-01436

View V

- (1) Application not required.
- (2) 40 mm (1.57 in)

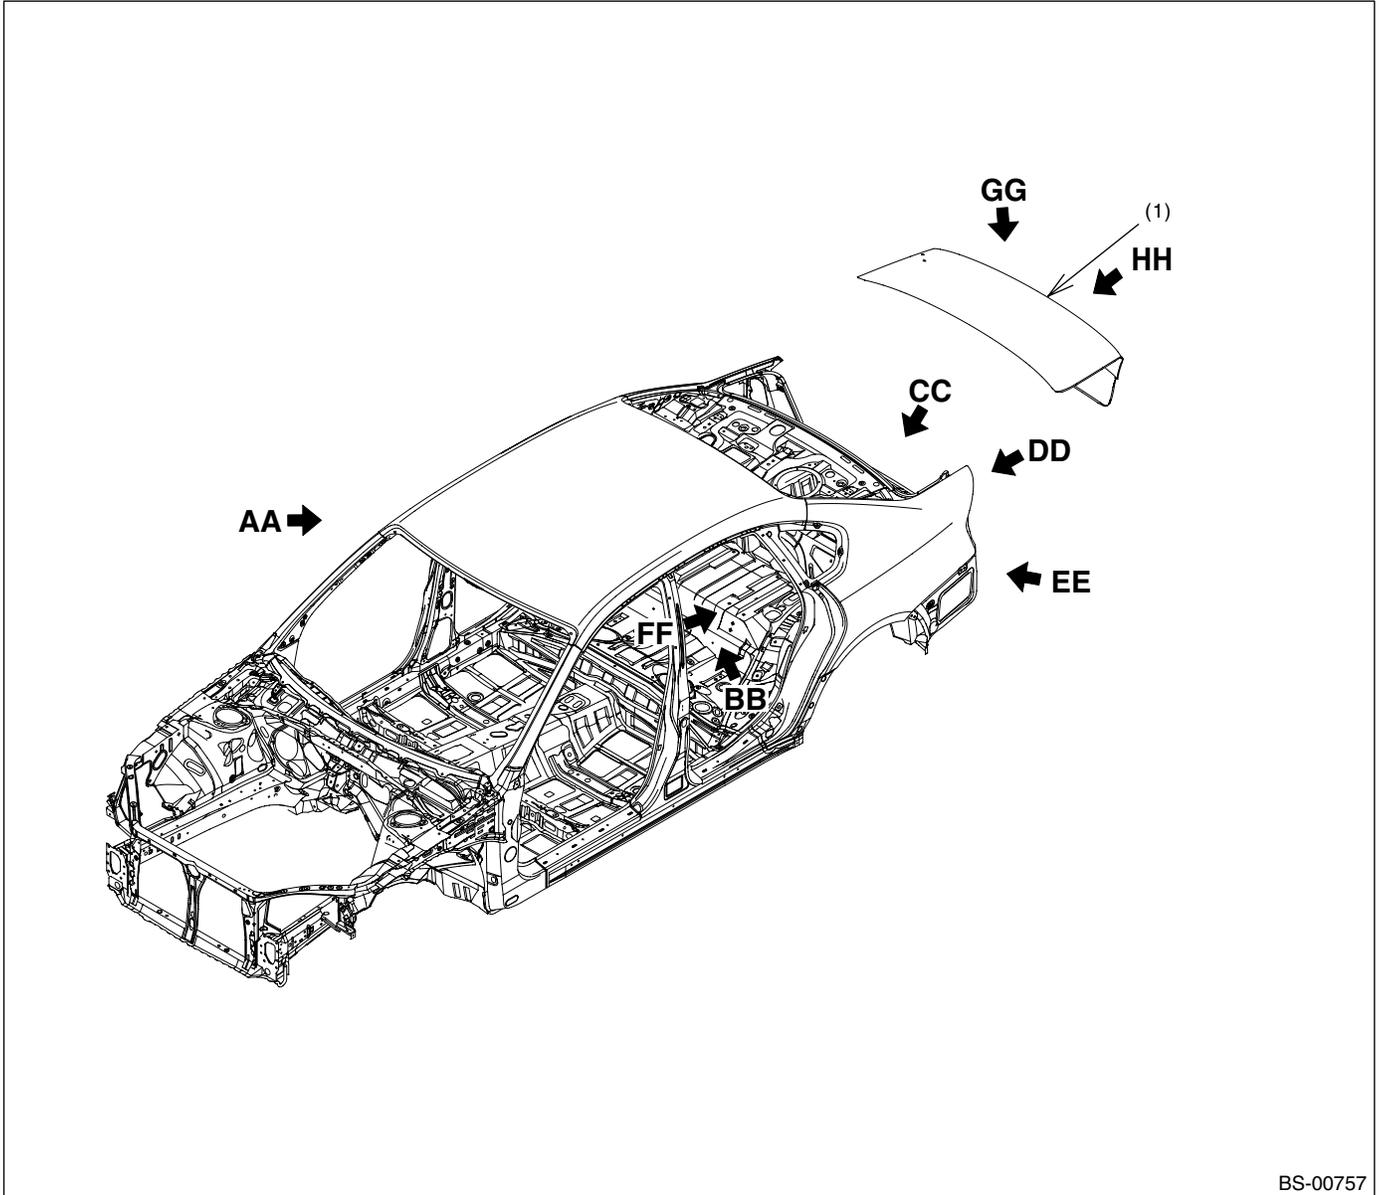
BS-00757

- Sedan model

(1) Trunk

Sealer already has been applied to the trunk in replacement condition.
