1. Door Glass

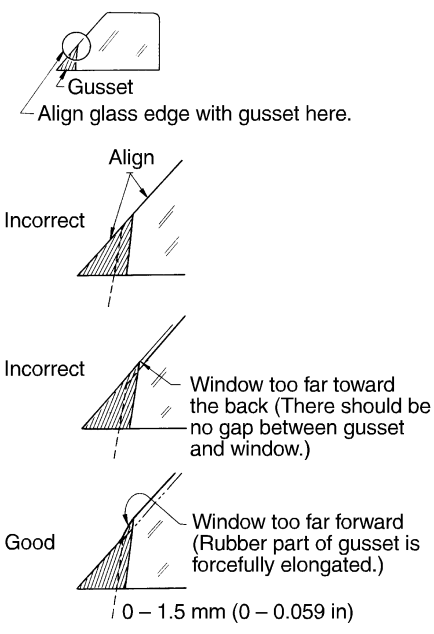
<p>3) Adjust door glass so that it is aligned with door rearview mirror gusset.</p>

<p style="text-align: right;">H5M0672C</p>	<ul style="list-style-type: none"> ● Window is not properly adjusted in up-down/fore-aft direction. Adjust window. If necessary, move B channel regulator to eliminate window tilt. ● Gusset is not properly adjusted in fore-aft direction. Adjust gusset after loosening all bolts and nuts with tightening it.

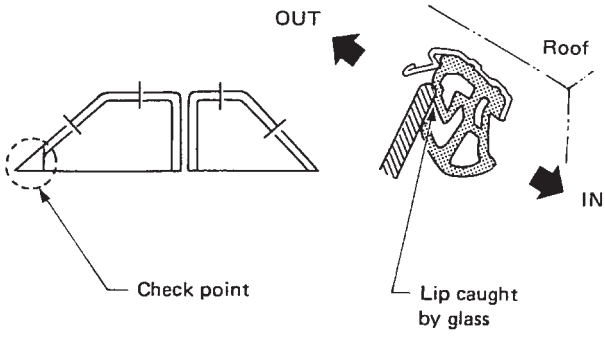
Condition	Apparent cause/Correction
<p>Door in fully closed/ open position</p>	<p>1) Glass rides over weatherstrip lip when door is closed.</p>

<p style="text-align: right;">G5M0505</p> <p>(This condition increases wind/booming noise, leakage and/or effort required to close door.)</p>	<ul style="list-style-type: none"> ● Improper up-down and in-out glass alignments <p>Adjust glass for up-down and in-out alignments (incl. rear sash, upper stopper adjustment, etc.). If necessary, correct glass tilt by moving B channel regulator.</p>
	<p>2) Edge of glass contacts retainer when door is fully closed.</p>

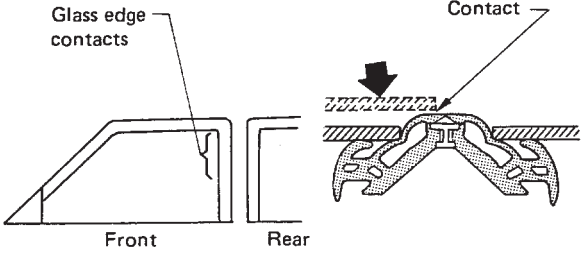
<p style="text-align: right;">G5M0506</p>	<ul style="list-style-type: none"> ● Improper glass-to-center pillar weatherstrip or excessive glass contact to weatherstrip ● Excessive adjusting in contact to weatherstrip <p>Causes rear edge of glass to tilt inboard closer to center pillar. Adjust rear sash adjustment bolt to reduce glass contact to weatherstrip.</p>
