20. Radio, Speaker and Antenna

A: REMOVAL AND INSTALLATION

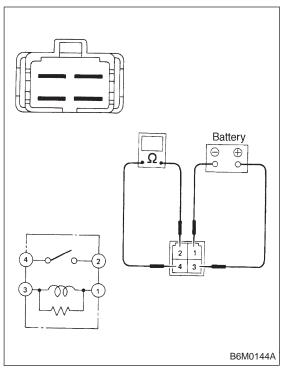
3. SUNROOF RELAY

Check continuity between terminals as indicated in table below, when battery voltage is applied between terminals No. 1 and No. 3.

When current flows.	Between terminals No. 2 and No. 4	Continuity exists.
When current does not flow.	Between terminals No. 2 and No. 4	Continuity does not exist.
	Between terminals No. 1 and No. 3	Continuity exists.
